Water Quality Observations and Recommendations for Trail Planning and Maintenance at Fairlee Town Forest

As Requested by Fairlee Town

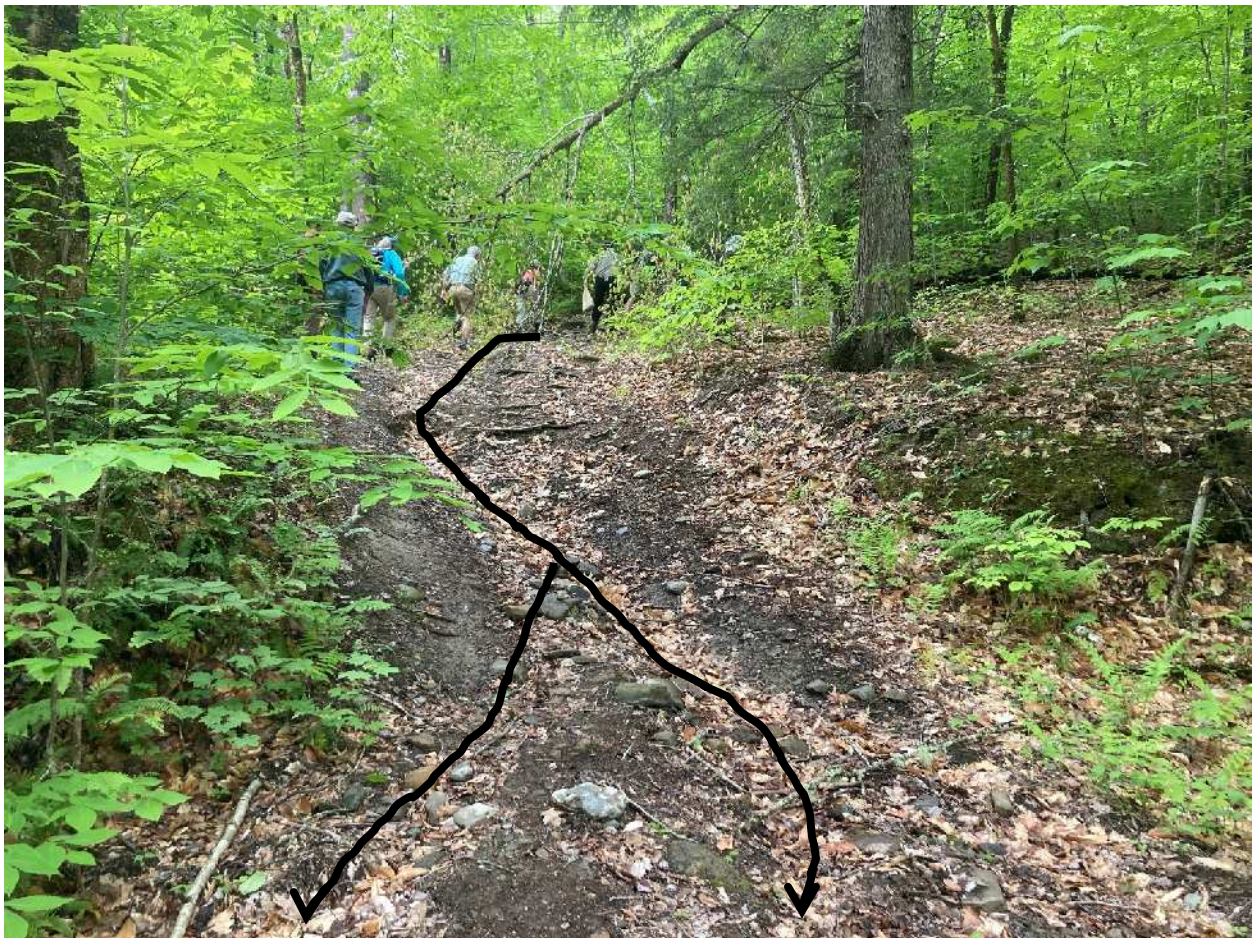
The group visited several areas with visible erosion features. Most of these features were observed on wide, steep slopes that were old skidder trails with no or minimal erosion control features (Figure 1 and 2).

Figure 1. An ephemeral stream channel has formed on this trail which channelizes water and sediment that flows downhill into the stream. After years of erosion, this trail is much lower than the surface of the forest floor.

FPR Logging AMPs and recommendations for trail design and maintenance from the FPR Recreation staff should be followed to ensure the correct management of trails and forestry infrastructure. Areas that are excessively steep and difficult and costly to manage should be retired and stabilized based on FPR trail standards. Any direct discharges should be mitigated as soon as possible to prevent discharge and address the cause of the discharge, this may include: installation of water bars and other best management practices for roads and logging activities, trail closure, and trail retirement and stabilization.

Any areas with evidence of direct discharge into surface waters should be prioritized for remediation. As these areas are addressed, it will be prudent to work with a recreational trail designer to assess the existing trails and develop a recreational trails plan that will guide future efforts to build a stable and long-lasting trail network and maintenance plan.

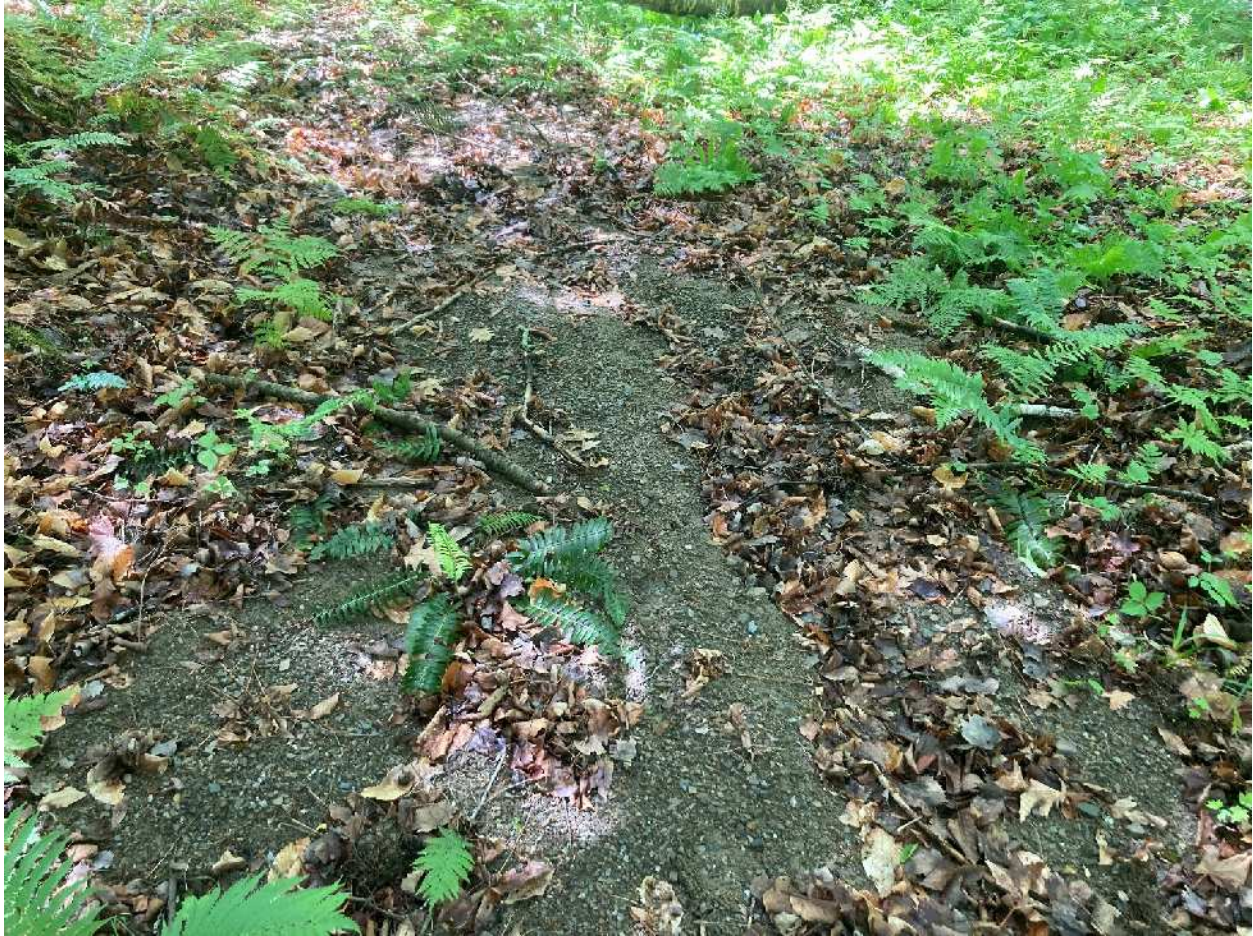
Figure 2. Sediment from the trail surface deposited downhill by the stream channel. Some of this sediment made its way directly into the stream channel. In this area, a second channel is eroding parallel to the stream channel. Further erosion could result in the stream “capturing” the old logging trail.

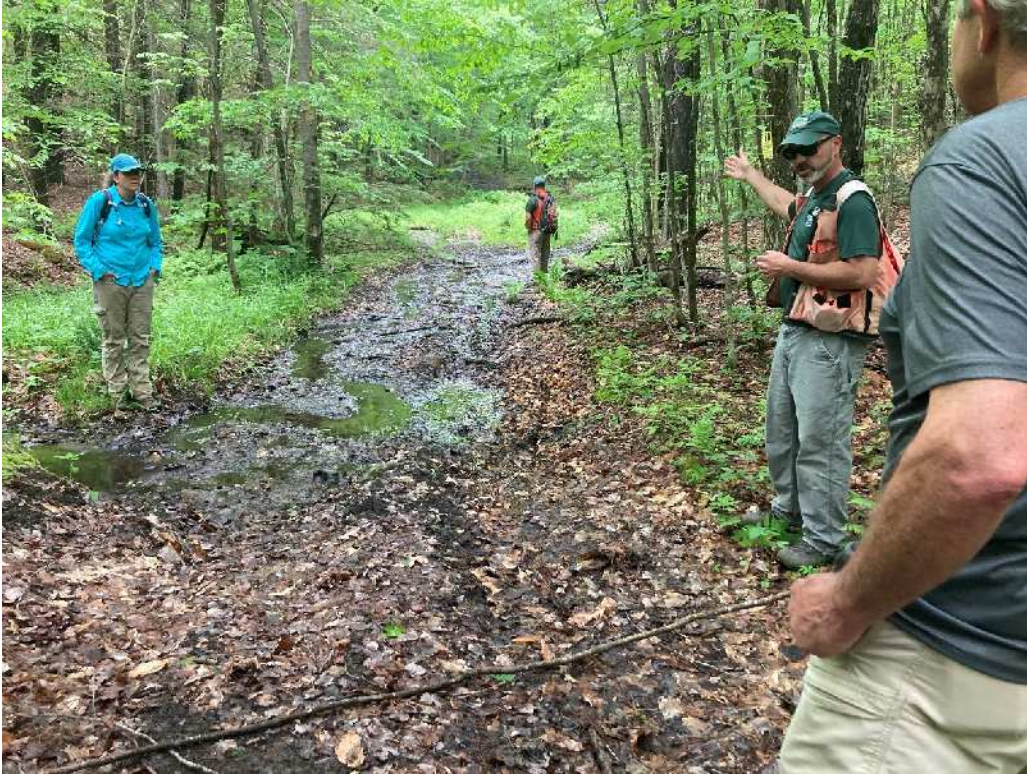
A second type of water quality issue was identified adjacent to the Fairlee Town Forest and appeared to be mostly caused by unregulated ATV use on private land. The trails crossed a series of connected wetland seeps that were partially destroyed, and the hydrology had been altered by the rutting and compaction caused by ATV use (Figure 3).

Figure 3. A seepage wetland with altered hydrology caused by unregulated ATV use. The seepage flow has been channelized and erosion of soil was evident into a small stream (outside to the left of the photo).

All ATV use in close proximity to beaver dams that impacts hydrology, creating ruts, and impacts dam structures, should be discontinued to prevent accidental failure of beaver dams and impact to aquatic and terrestrial species that rely on the beaver wetland complex for survival.

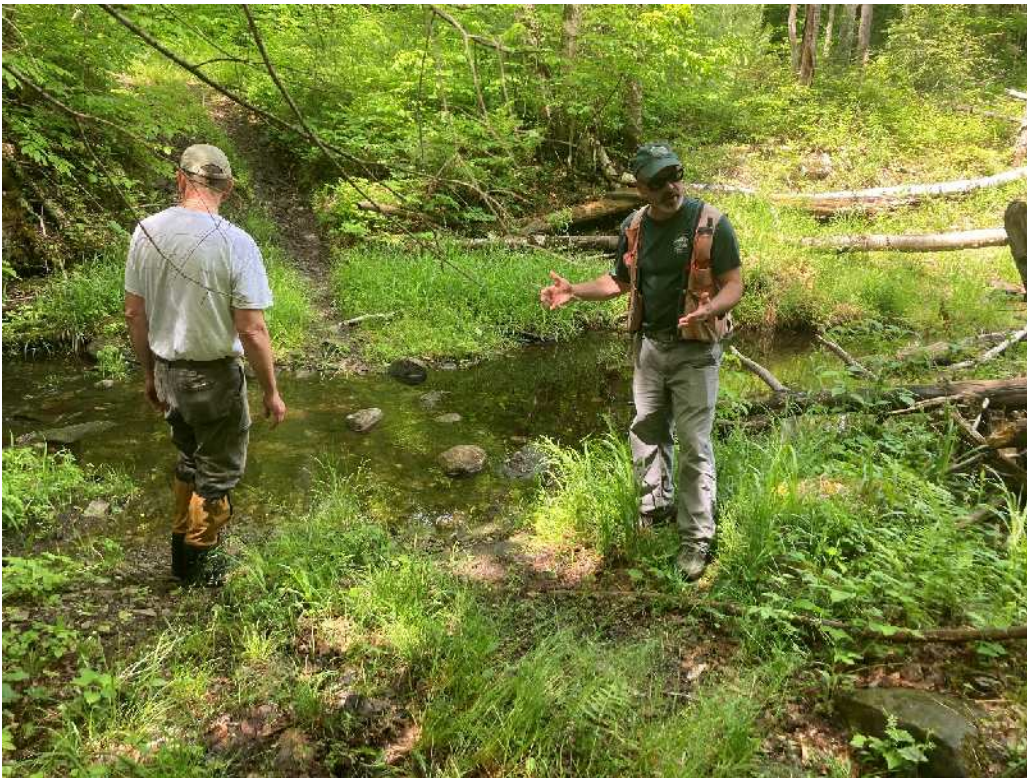
We visited on small ford crossing that was experiencing some erosional impacts but was not in bad condition. A few options were identified for addressing future erosion in that area (Figure 4). Beaver activity was observed upstream of the ford site and the beaver dams have failed in years past. Beaver activity is common in most upland forested areas where streams flow through gently sloping open terrain. Beaver wetland complexes support many wildlife functions and create aquatic and open meadow habitats in forested areas. Excessive ATV use by and around beaver wetlands can weaken dams and cause dam failure.

Figure 4. Stream ford crossing below beaver wetland complex.
